Manhole Inspection Summary

Manhole # S47I__004MH

Location Address: **2111 s duncan st**

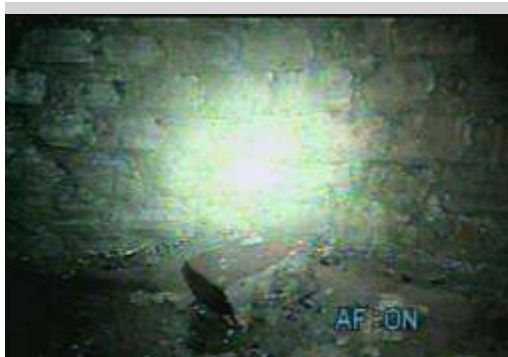
Defect 3

Condition: ☐ Sound ☐ Cracked ☐ Root Intrusion ☐ Deteriorated ☐ Leaks ☒ **Debris**

channel debris

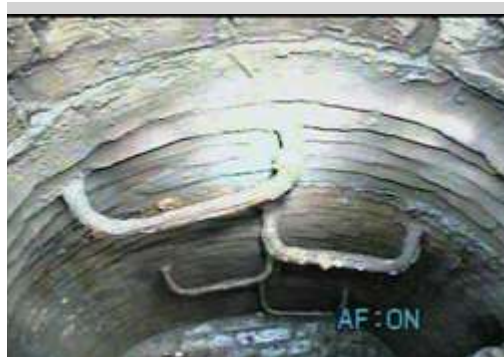
Defect 2

Count: **4** Missing: **0** ☒ **Corroded**

corroded stairs

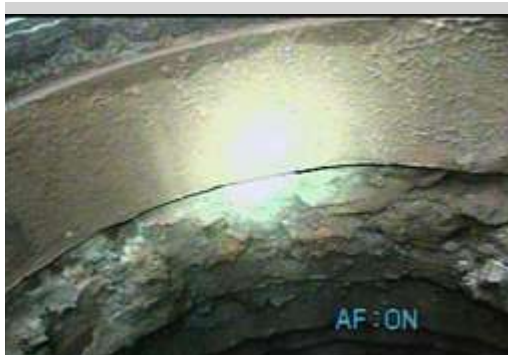
Defect 1

Condition: ☐ Sound ☐ Cracked ☐ Root Intrusion ☐ Loose Brick ☒ **Deteriorated**

Chimney deteriorated, frame adjustment
